LESSONS LEARNED ABOUT ACTIVATED CARBON INJECTIONS ON A SITE IN WYOMING

AUTHORS:
THERESA SORRELLS (TREE@ALPINEREMEDIATION.COM) (ALPINE REMEDIATION, GOLDEN, CO USA)
JOHN SKOGMAN (JOHN.SKOGMAN@TERRACON.COM) (TERRACON, FT. COLLINS, CO USA)

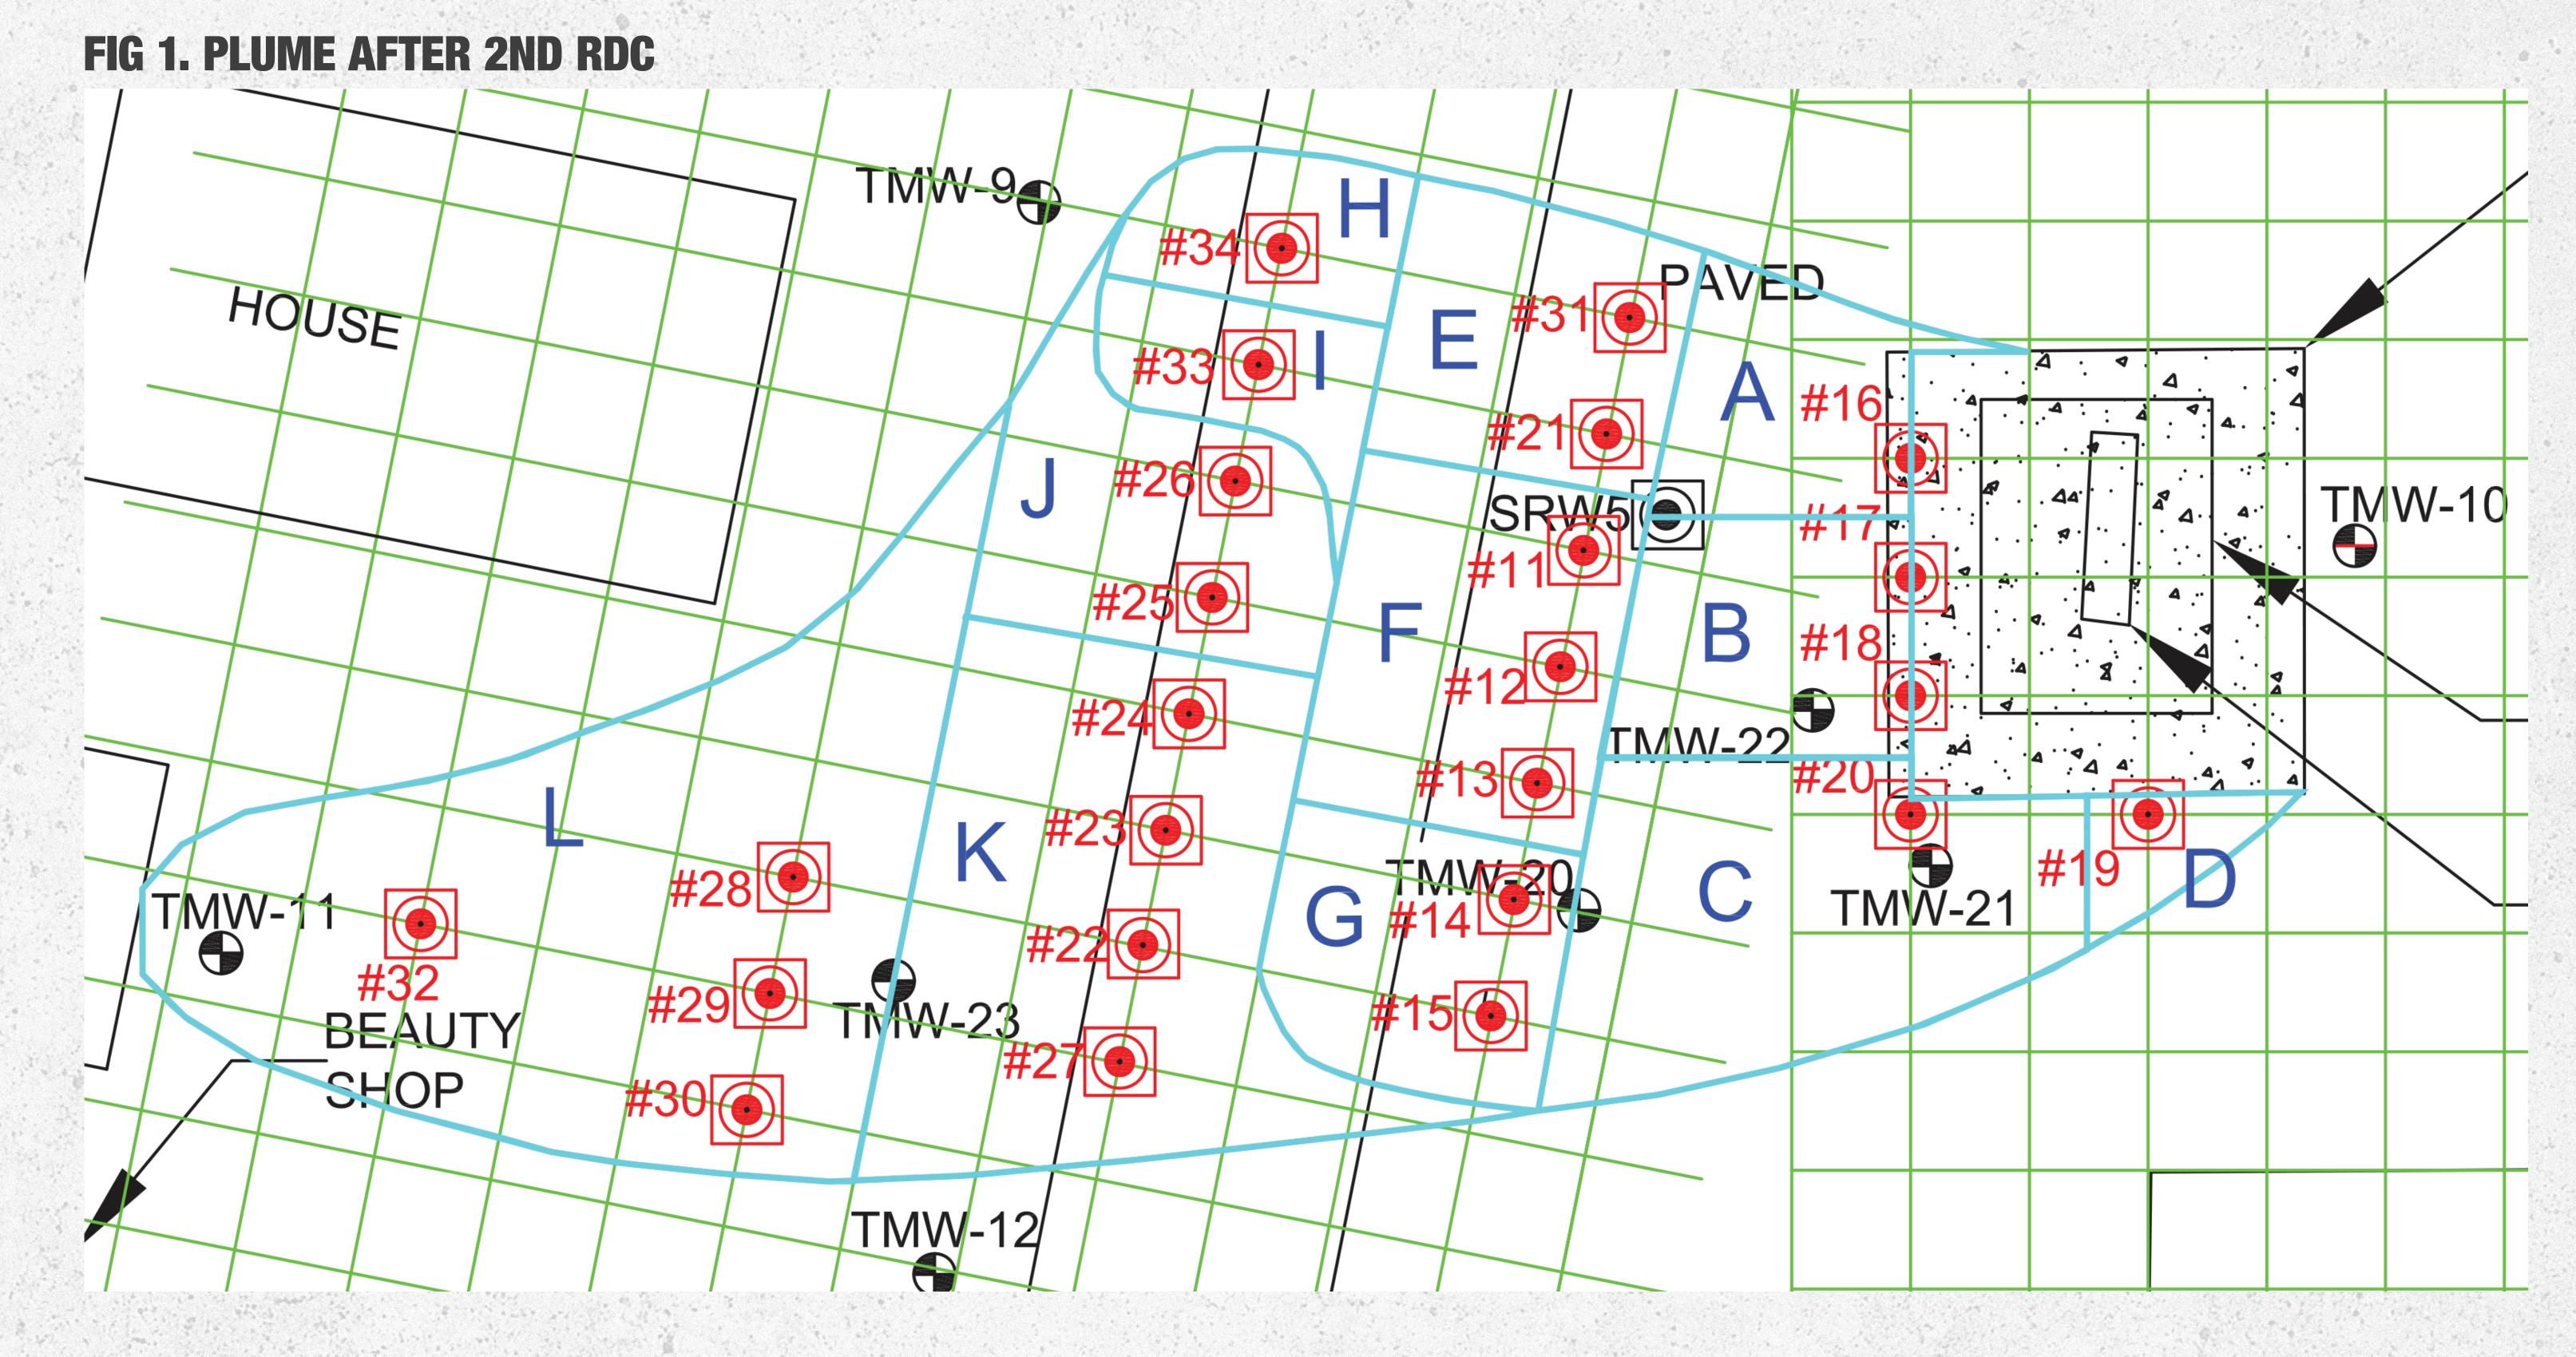
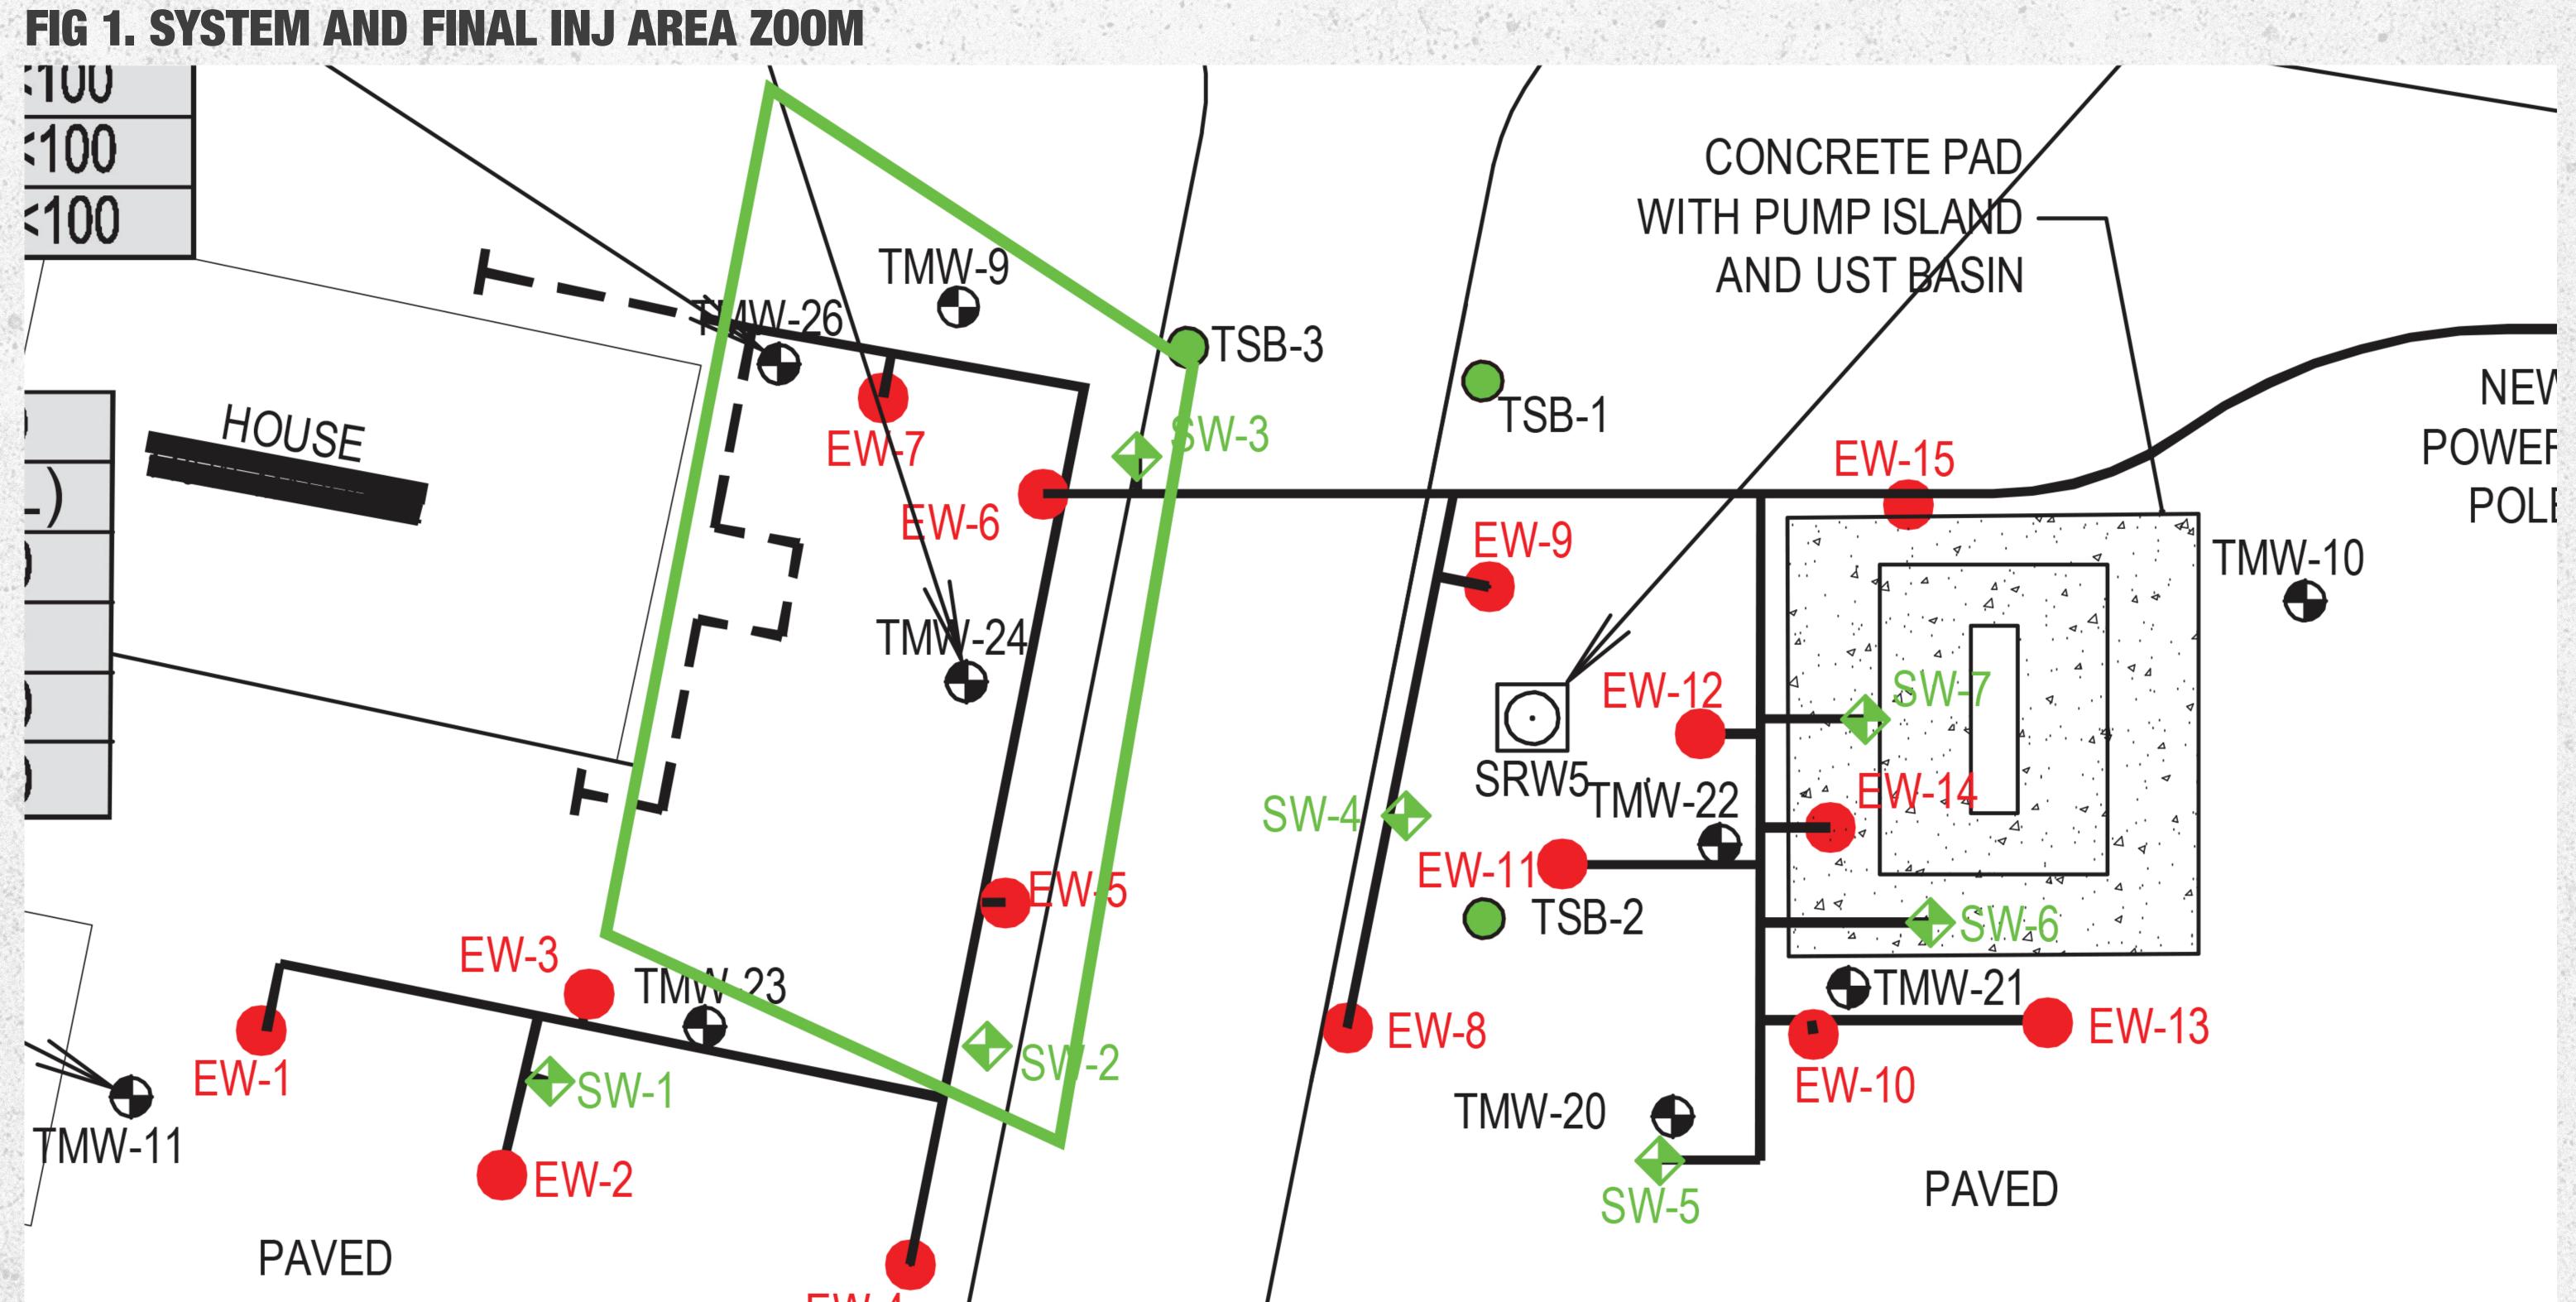
- The system ran for 8 years.
- Injections of 5,000 pounds of BOS 200® was completed at the site in the summer of 2018.
- Site closure was requested in March of 2020 based on 3 consecutive quarters of groundwater concentrations below the designated cleanup levels.
